**STREAM HABITAT ASSESSMENT FOR THE  
CITY OF DUVALL, WASHINGTON**

**Existing Conditions Report**

Herrera Environmental Consultants, Inc.  
2200 Sixth Avenue, Suite 601  
Seattle, Washington 98121  
Telephone: 206/441-9080

April 11, 2006

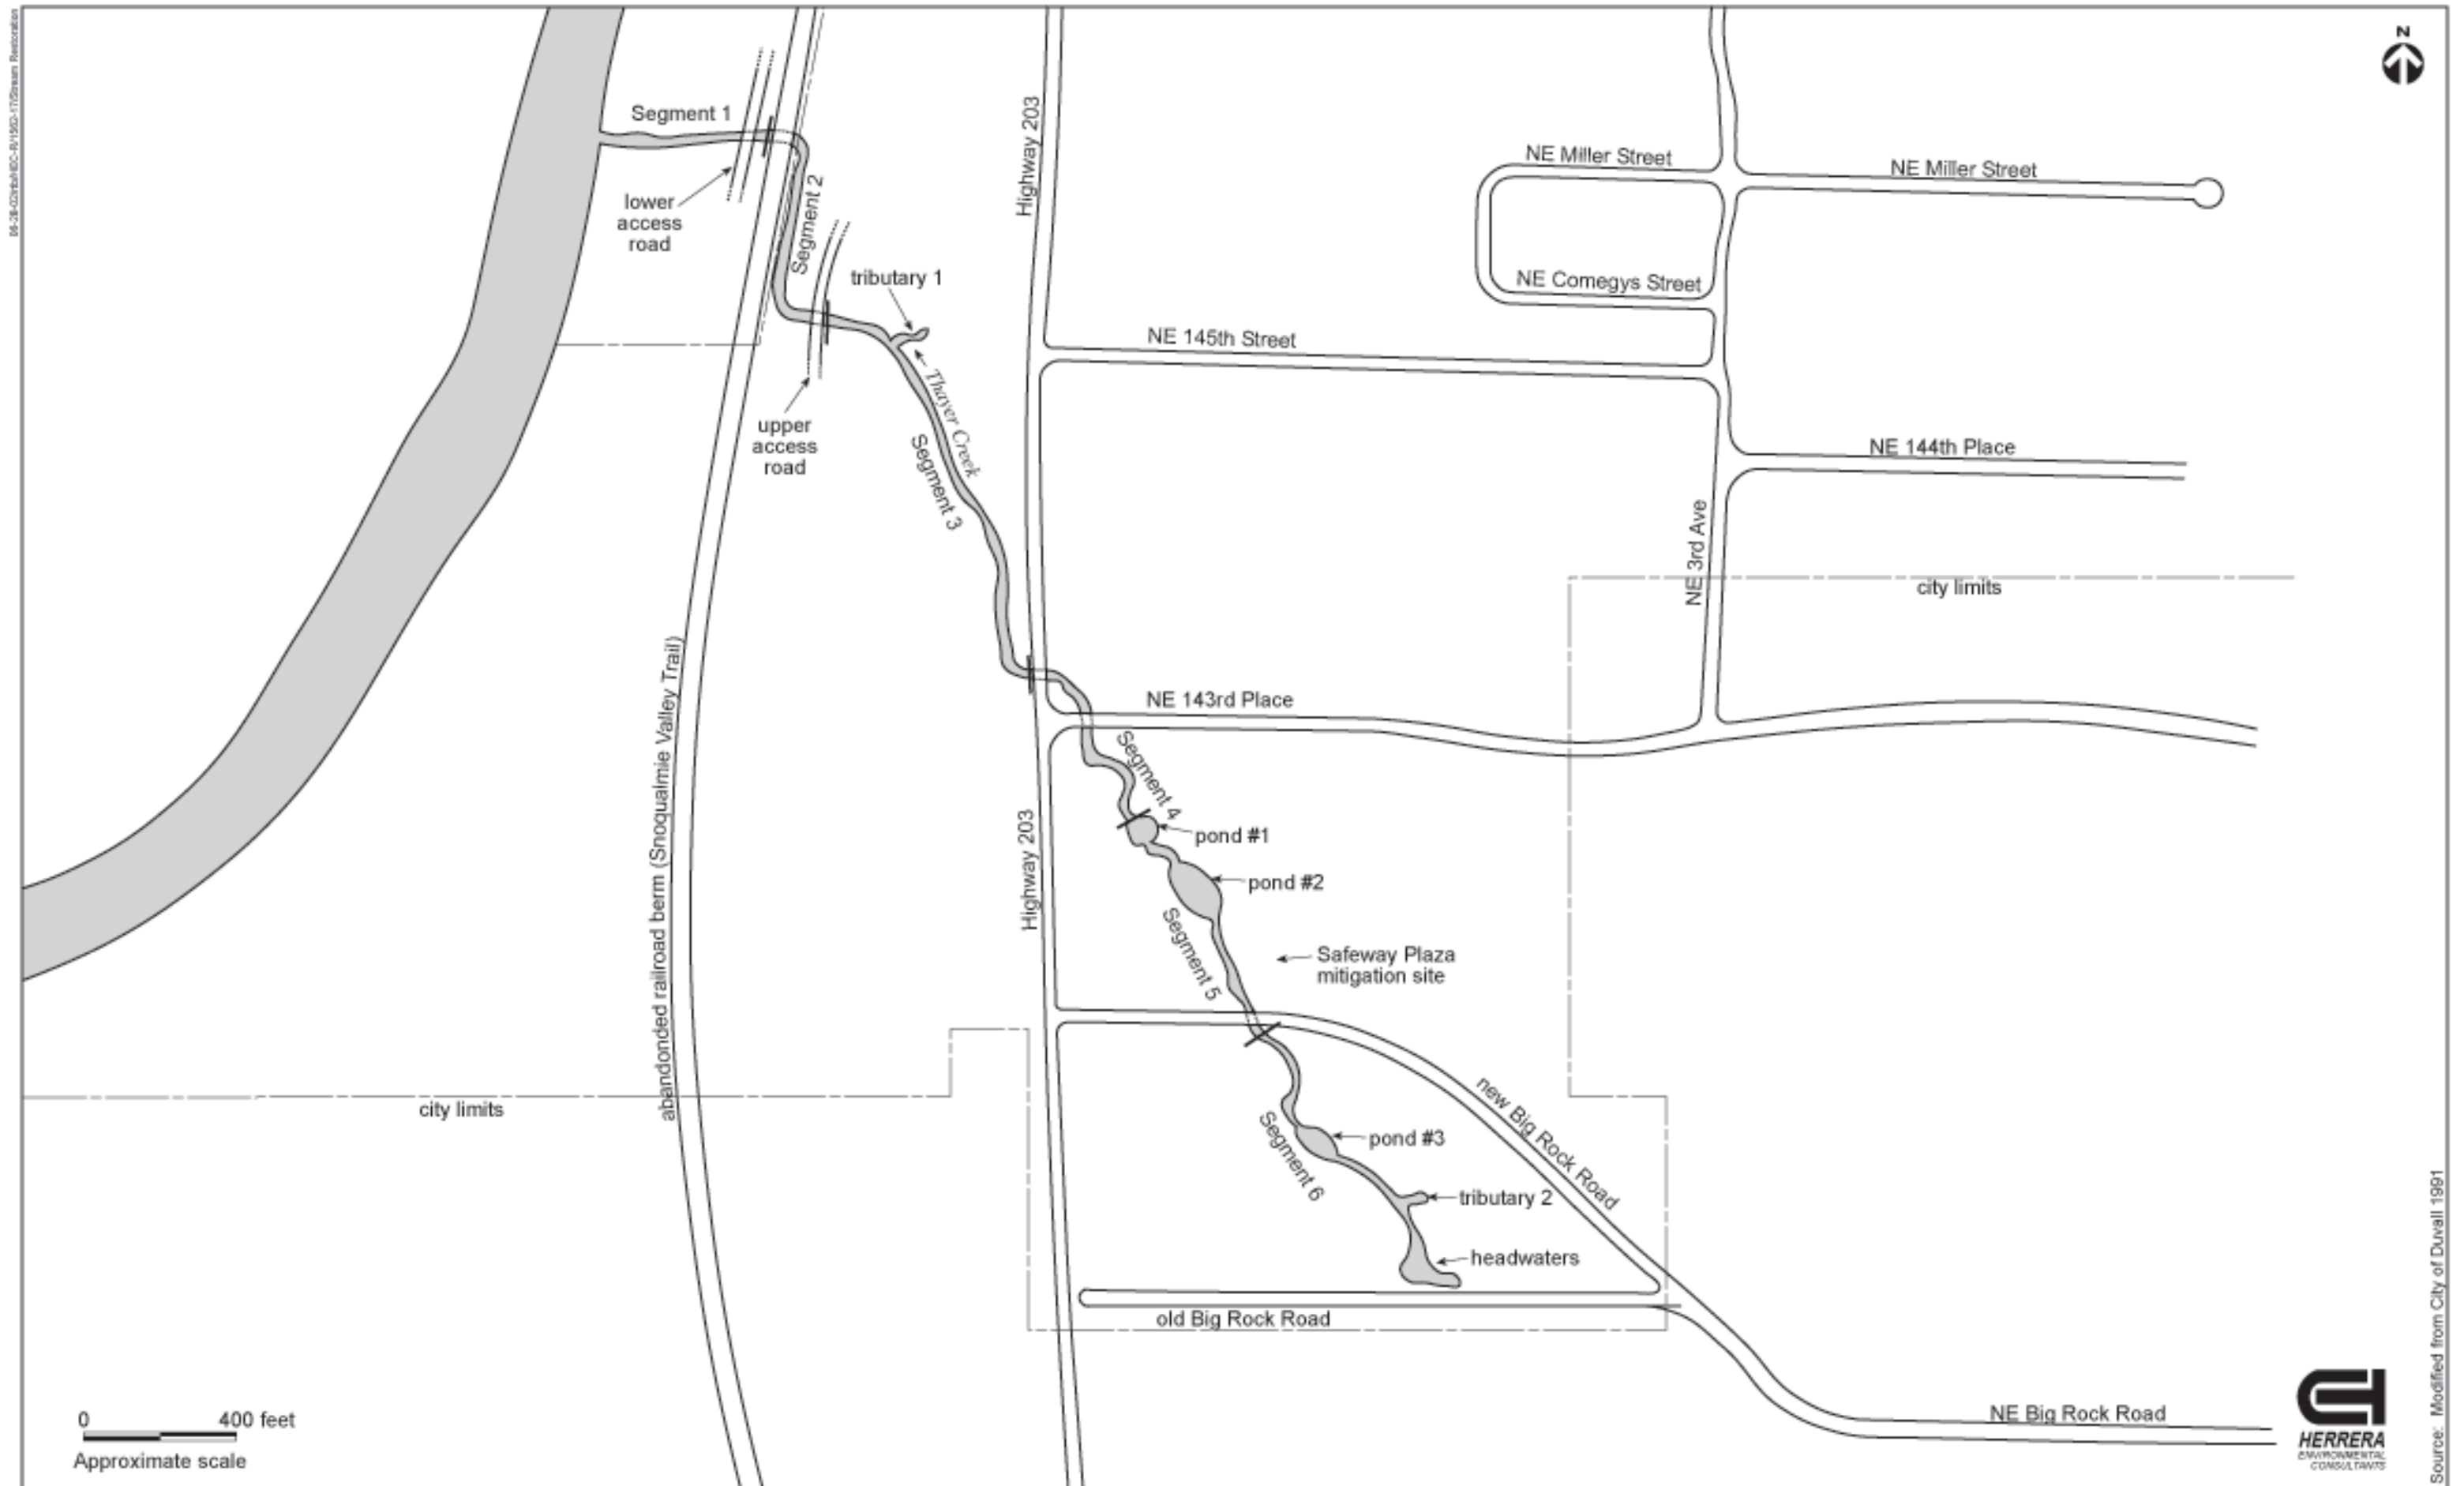
Figure 3. Channel configuration of Thayer Creek within the City of Duvall.

The main stem of Thayer Creek has been divided into sixth segments (see Figure 3) based on channel gradient, migration barriers, substrate, and riparian zone conditions. The first segment (433 feet long) lies within the Snoqualmie River floodplain and extends from the confluence with the Snoqualmie River to the Snoqualmie Valley Trail. The second segment (510 feet long) extends from the Snoqualmie Valley Trail to a culvert underneath an access road (referred to as the upper access road). The third segment (1,295 feet long) extends from the upper access road to the culvert underneath Highway 203. The fourth segment (541 feet long) extends from

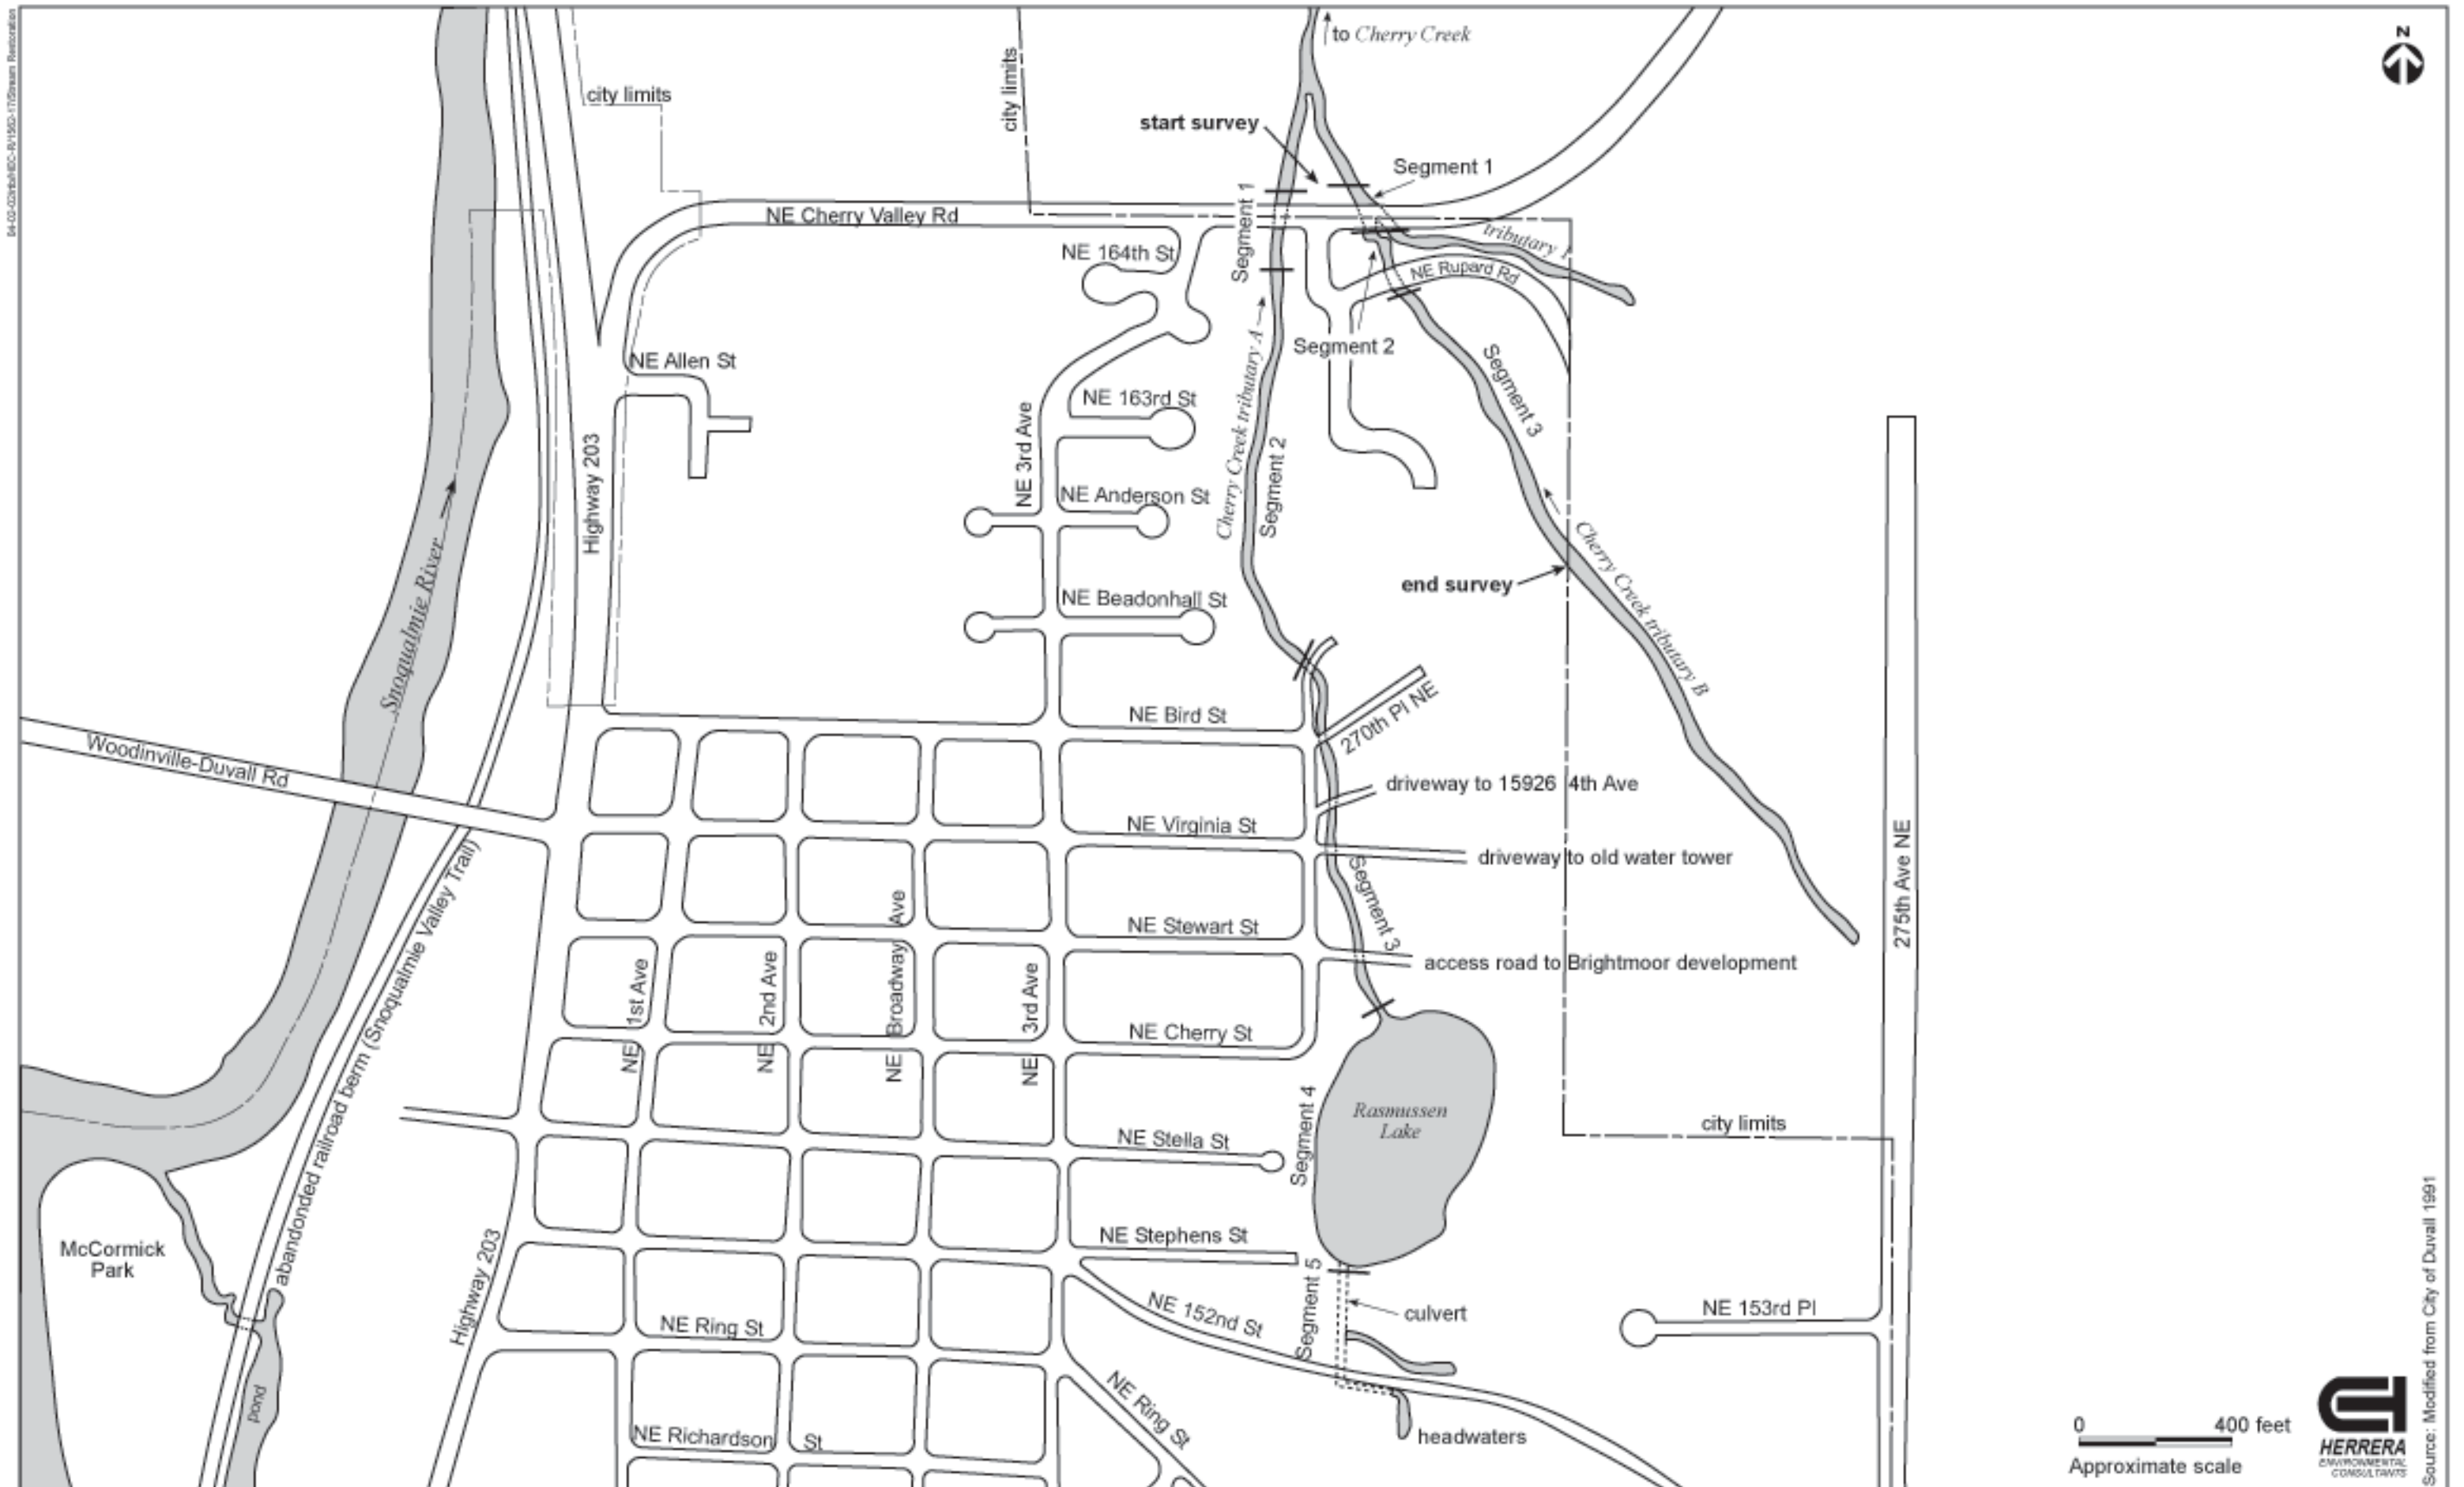
Figure 5. Channel configuration of Cherry Creek tributary A and B within the City of Duvall.

The main stem of Cherry Creek tributary A has been divided into five segments (see Figure 5) based on channel gradient, migration barriers, substrate, and riparian zone conditions. The first segment (256 feet long) flows through emergent wetlands on both sides of NE Cherry Valley Road. The second segment (997 feet long) extends upstream of NE Cherry Valley Road to a culvert underneath NE 4th Avenue. The third segment (1,070 feet long) extends from the NE 4th Avenue culvert to Rasmussen Lake. The fourth segment (577 feet long) consists of Rasmussen Lake. The fifth segment (378 feet long) extends from Rasmussen Lake to the headwaters near NE 152<sup>nd</sup> Street.

The main stem of Cherry Creek tributary B has been divided into three segments (see Figure 5) based on channel gradient, migration barriers, substrate, and riparian zone conditions. The first segment (62 feet long) flows through emergent wetlands downstream of NE Cherry Valley Road. The second segment (279 feet long) extends upstream of NE Cherry Valley Road to a culvert underneath NE Rupard Road. The third segment (1,088 feet long) extends from the NE Rupard Road culvert to the City of Duvall corporate limits. A tributary (designated as Tributary 1) combines with the mainstem channel at the downstream side of NE Cherry Valley Road.
